DAM SECTION A

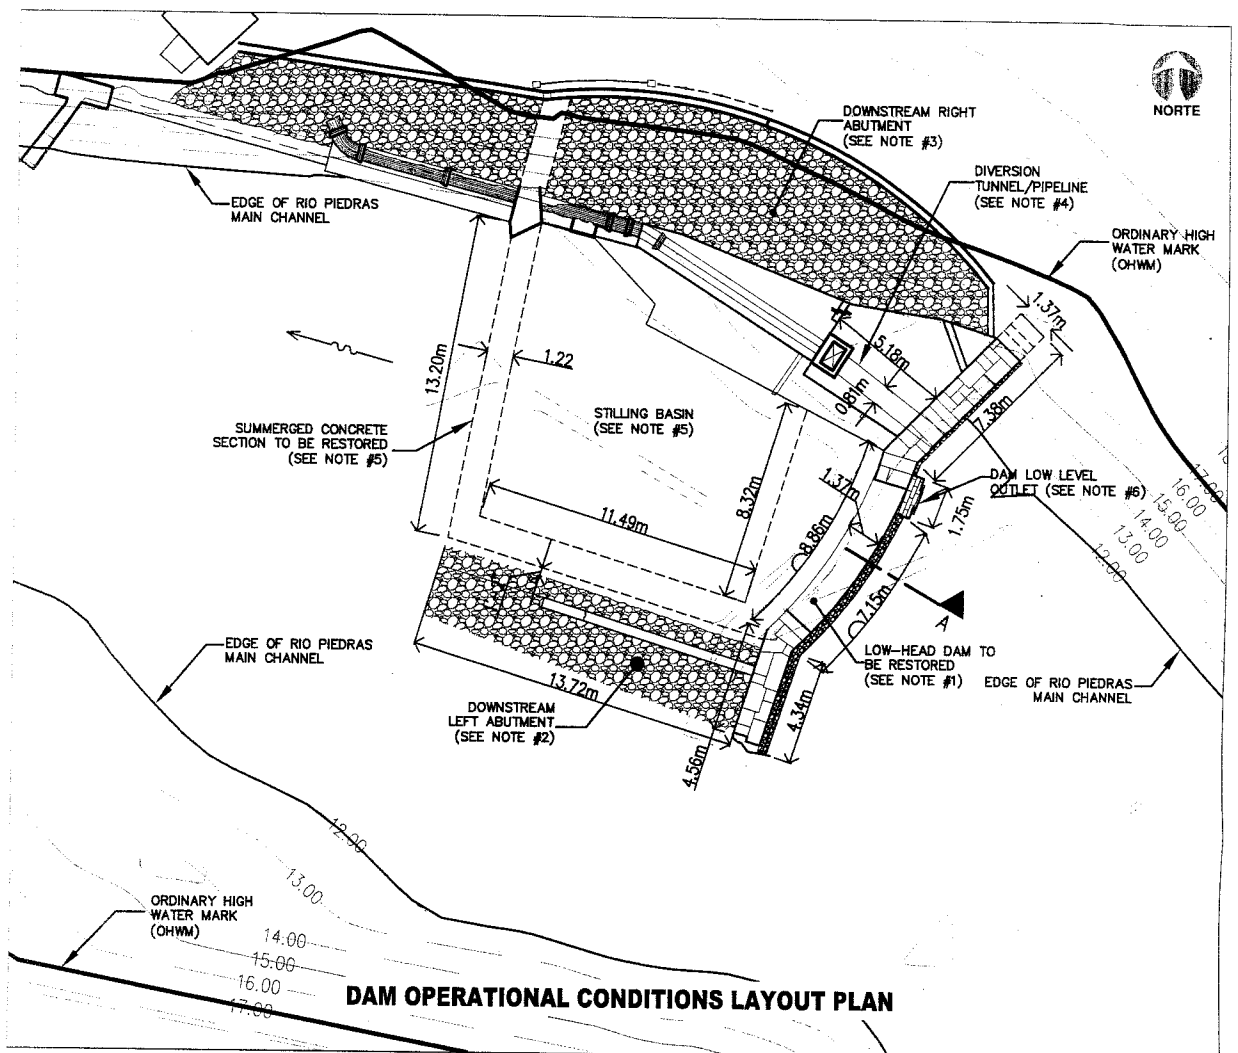
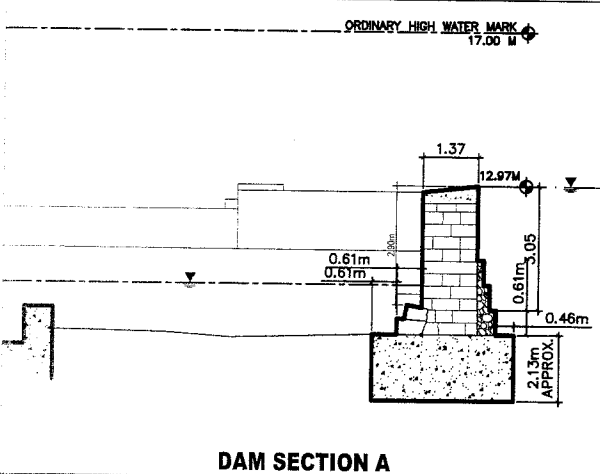
1. THE LOW-HEAD DAM HAS BEEN DAMAGED BY STREAMFLOWS AND IS CURRENTLY DISPLACED BOTH HORIZONTALLY AND VERTICALLY. IT WILL BE RESTORED AS CLOSE AS POSSIBLE TO ITS ORIGINAL CONDITIONS.

2. THE LEFT ABUTMENT HAS BEEN WASHED AWAY BY STREAMFLOWS AND THE STREAM IS CURRENTLY FLOWING THROUGH THIS SIDE OF THE RIVER. THIS ABUTMENT WILL BE RESTORED AND PROVIDED WITH A CONCRETE PLUG/WALL TO MINIMIZE THE CHANCE OF OCCURRING AGAIN. THE CHANNEL SLOPE WILL BE LINED WITH RIP/RAP OR AN APPROPRIATE LAYER FOR STABILITY.

3. THE DOWNSTREAM RIGHT ABUTMENT IS IN GOOD CONDITIONS AND WE DO NOT ANTICIPATE RESTORATION WORKS ON THIS AREA. PLEASE SEE NOTE #4.
4. THE DIVERSION TUNNEL/PIPE HAS BEEN PARTIALLY DAMAGED IN THE AREAS NEAR THE DAM STRUCTURE AND WILL BE RESTORED AS CLOSE AS POSSIBLE TO ITS ORIGINAL CONDITIONS.

5. ORIGINAL DESIGN ILLUSTRATES A SUBMERGED CONCRETE WALL/BEAM DOWNSTREAM THE DAM. THIS BEAM PRESUMABLY DEFINED THE LIMITS OF THE STILLING BASIN DOWNSTREAM THE DAM AND WILL BE RESTORED AS REQUIRED. THE STILLING BASIN WILL BE PROVIDED WITH BURIED RIP RAP.

6. THE LOW LEVEL OUTLET WILL BE RESTORED AND WILL SERVE ALSO AS THE FISHWAY WATER OUTLET AND FISH ENTRANCE.
7. THE UPSTREAM POOL IS CURRENTLY EMPTY AS A RESULT OF THE MIGRATION OF THE STREAM AROUND THE DAM THROUGH THE LEFT ABUTMENT. THE UPSTREAM POOL WILL BE RESTORED WHEN THE RESTORATION WORKS ARE COMPLETED.
